Constructing Excellence Forum

Hammersmith Flyover Strengthening Phase 2

11th February 2015

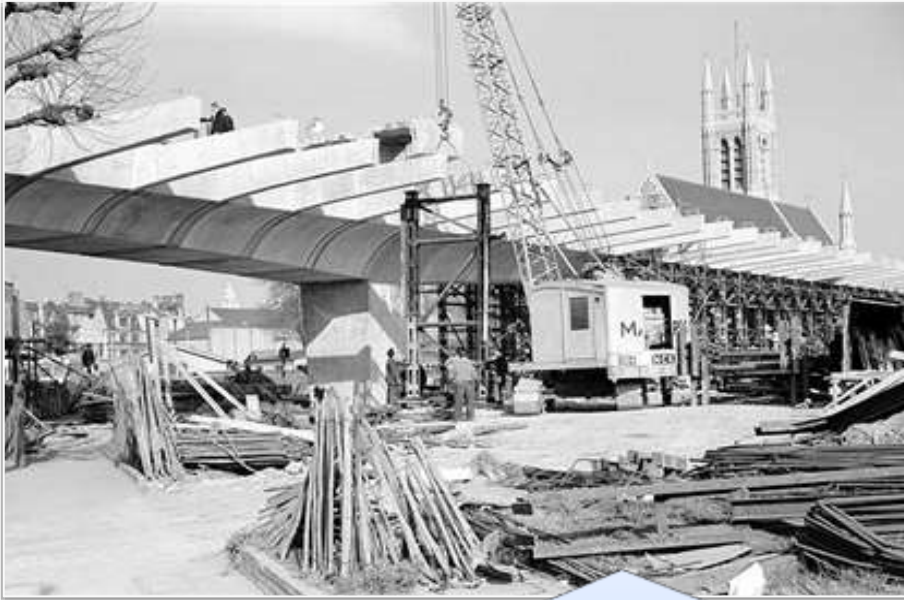
Construction of the bridge 1959-1962

Designed by G. Maunsell and Palmers

Built by Marples Ridgeway and Partners

Cost approximately £1.2M

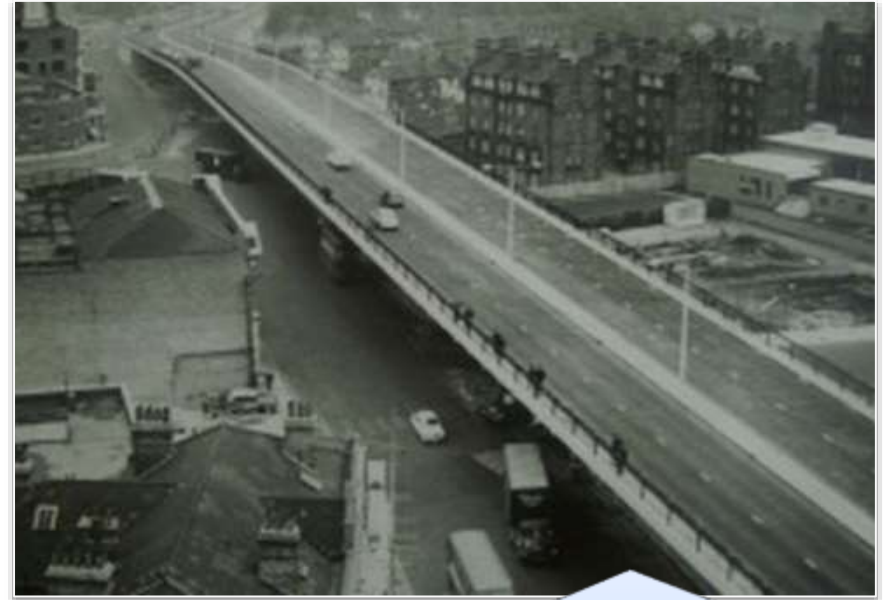
Elevated length 16 spans - 622.7 metres

Length with approach ramps is 862.9metres

Dual 2 lane carriageways

Overall width 18.6 metres

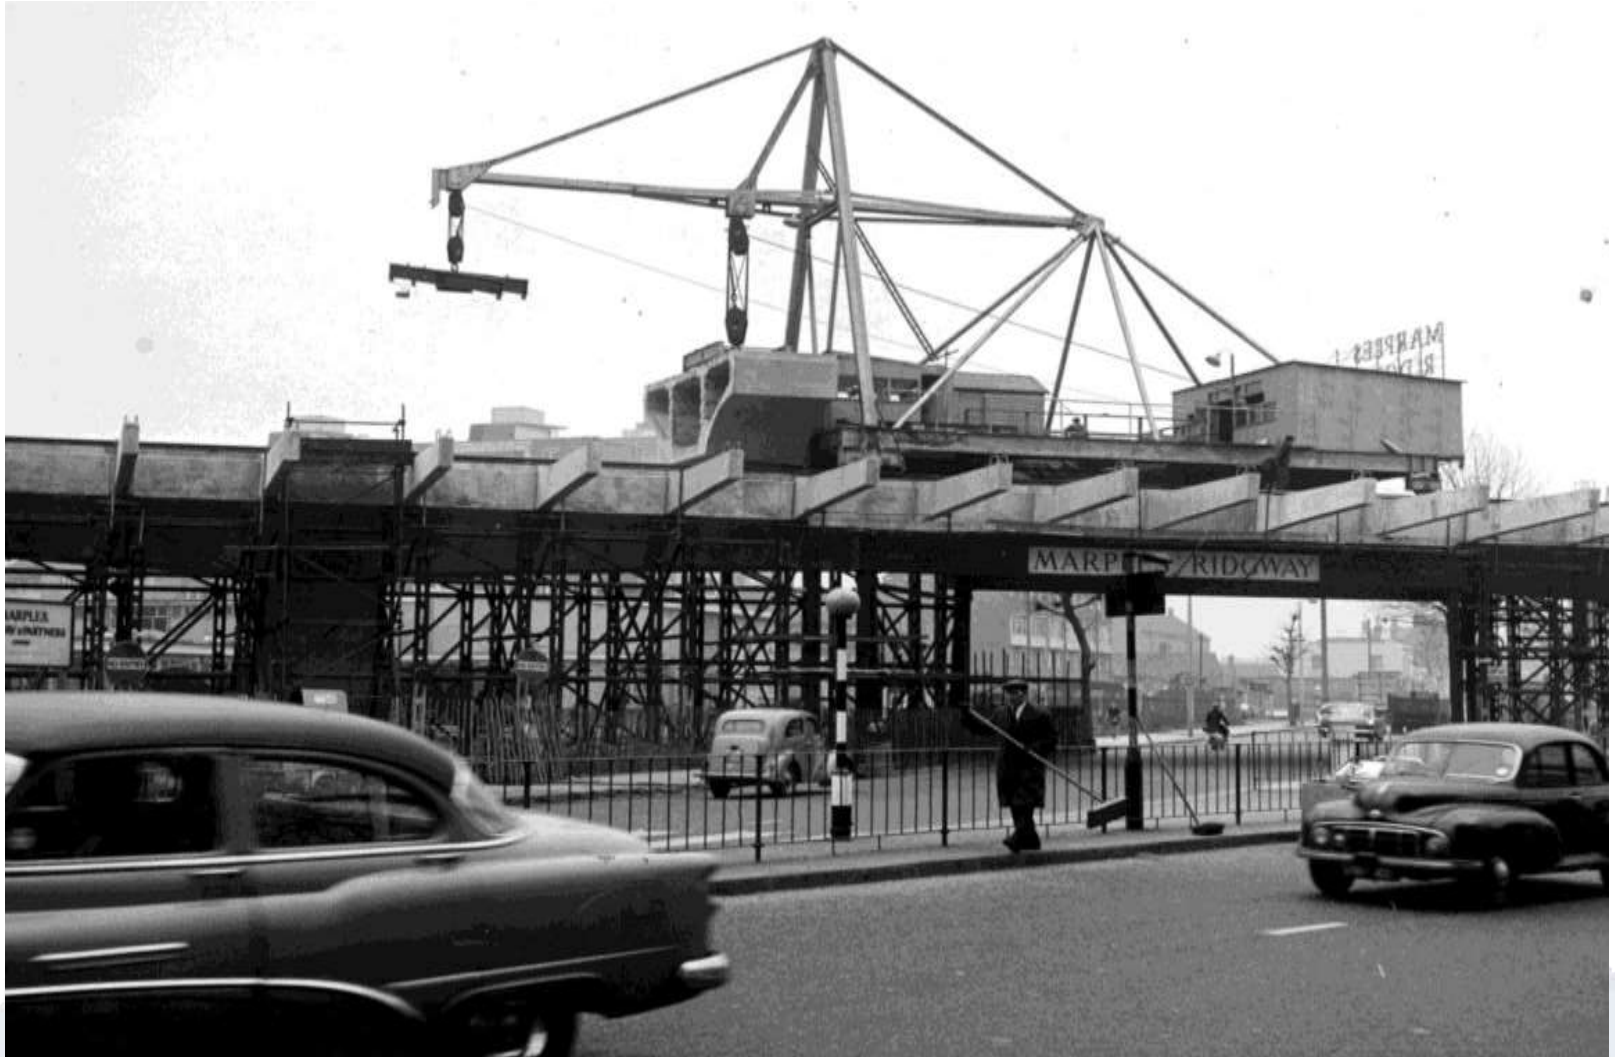
- Comprises 16 spans of post tensioned segmental construction
- Each span tensioned by longitudinal tendons -four clusters, 19no, 29mm steel cables

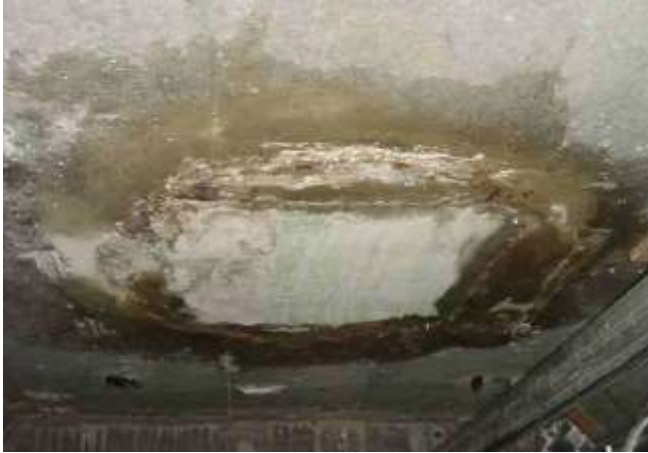
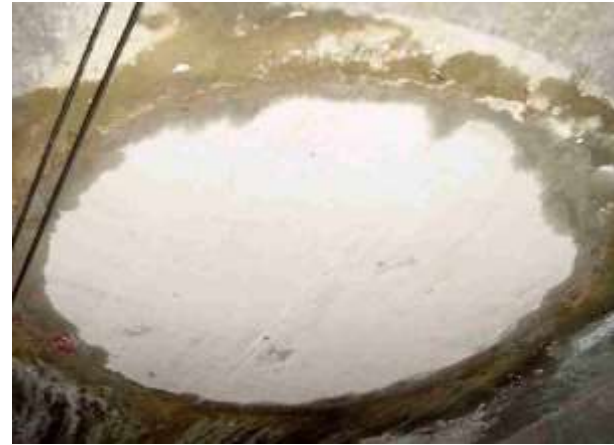
Extensive water leakage

- This ingress of water, over a number of years, has led to corrosion of the existing post tensioning system

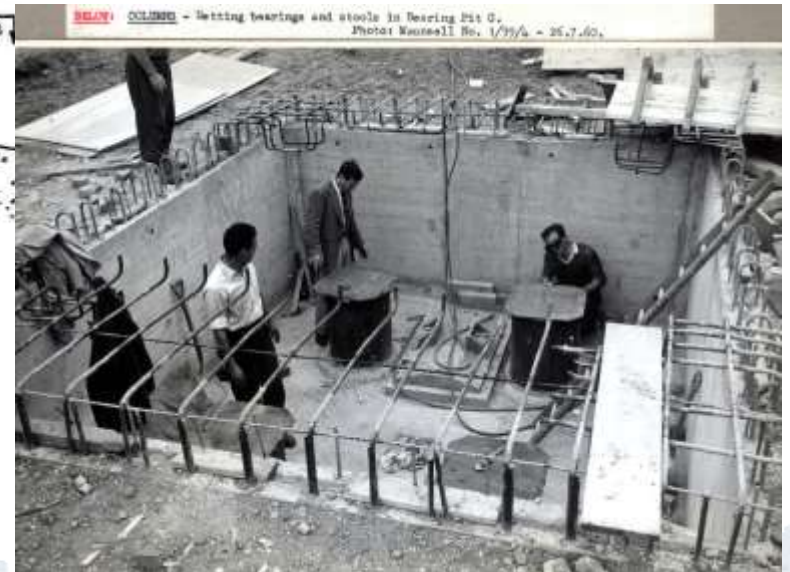
- Existing Bearing Pits

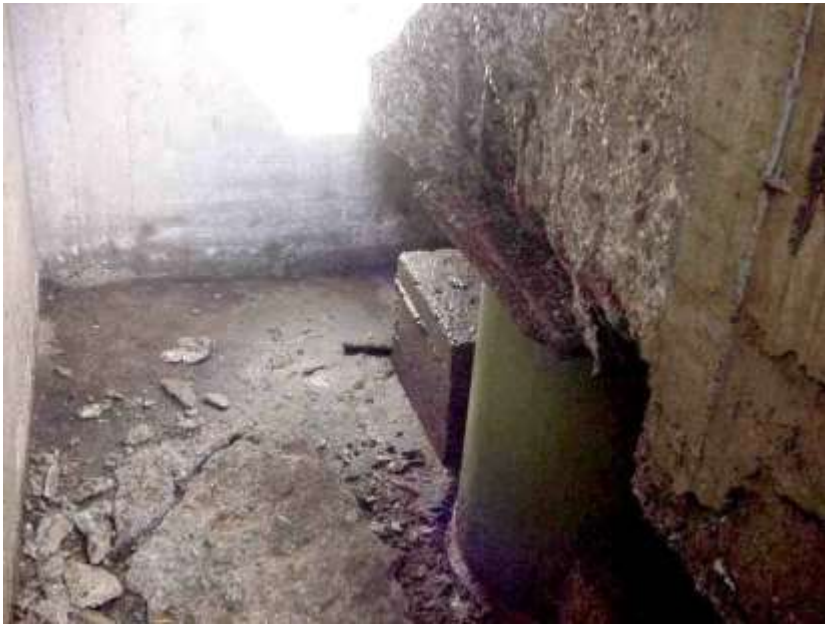
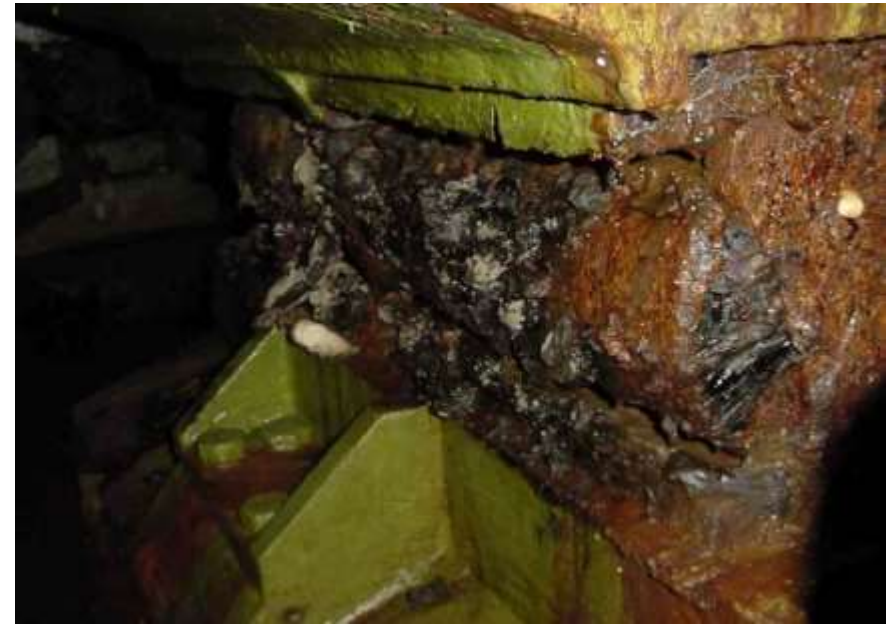
- Corrosion of stools has led to steel shim expansion and thus spalling of concrete, failure of drainage system has led to bearings being immersed in water over a period of time with extensive corrosion

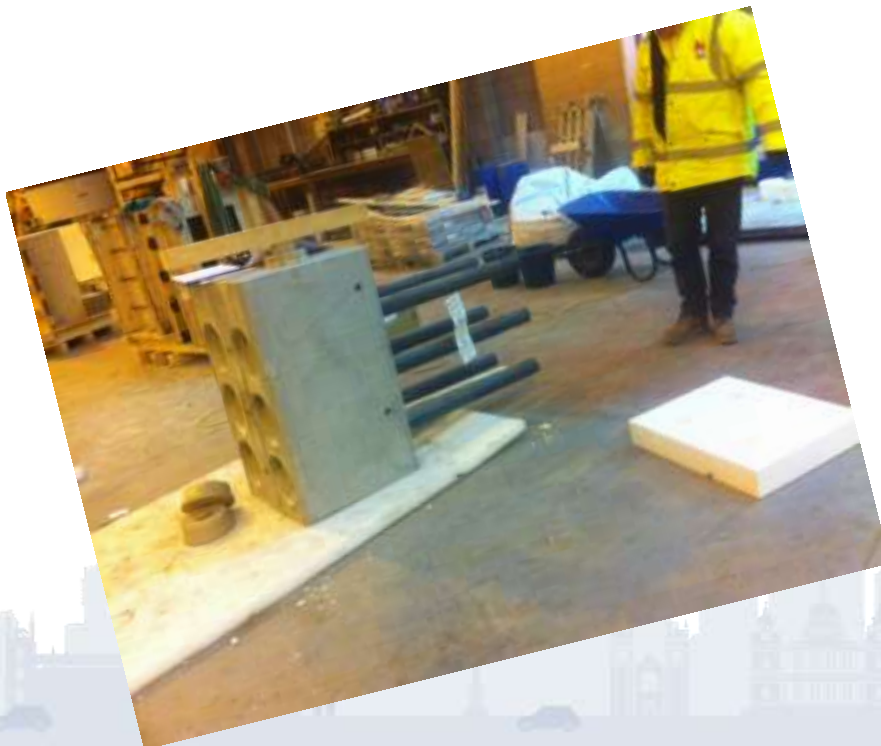
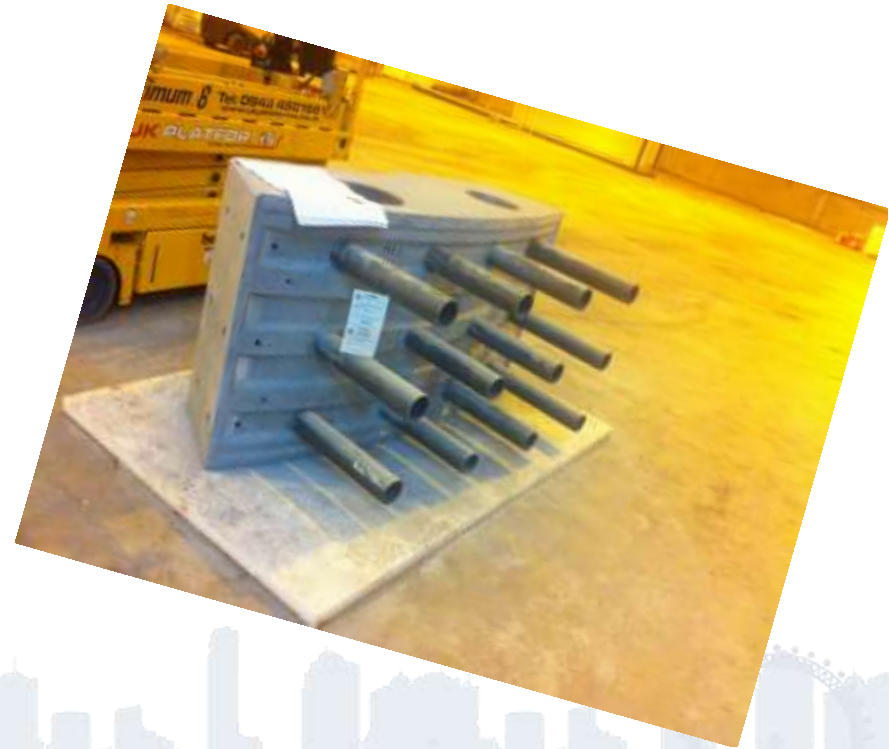
- Each pier capping tendon and mid span tendon is attached to an anchorage or “blister” which in turn is attached to the structure via a series of stressed bars
- Ultra High Performance Fibre Reinforced Concrete
- Each blister weighing in excess of 2T

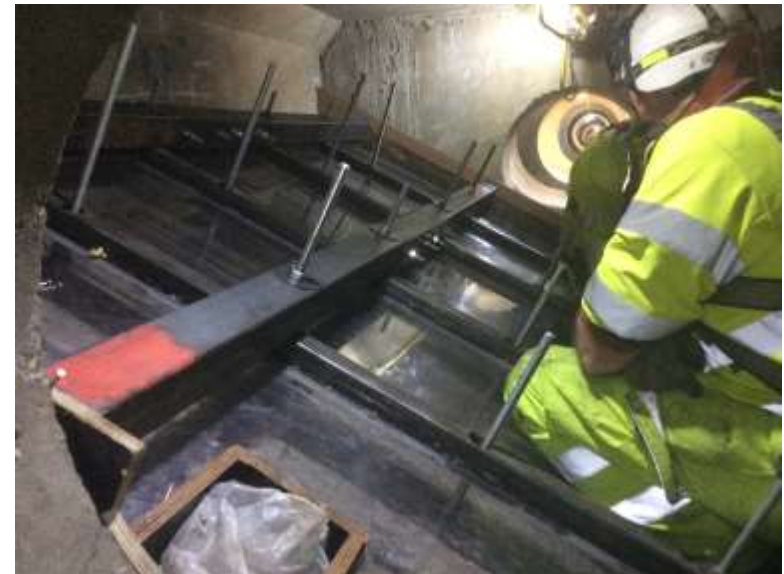
Challenge 1: In-situ backing slabs to transfer loads

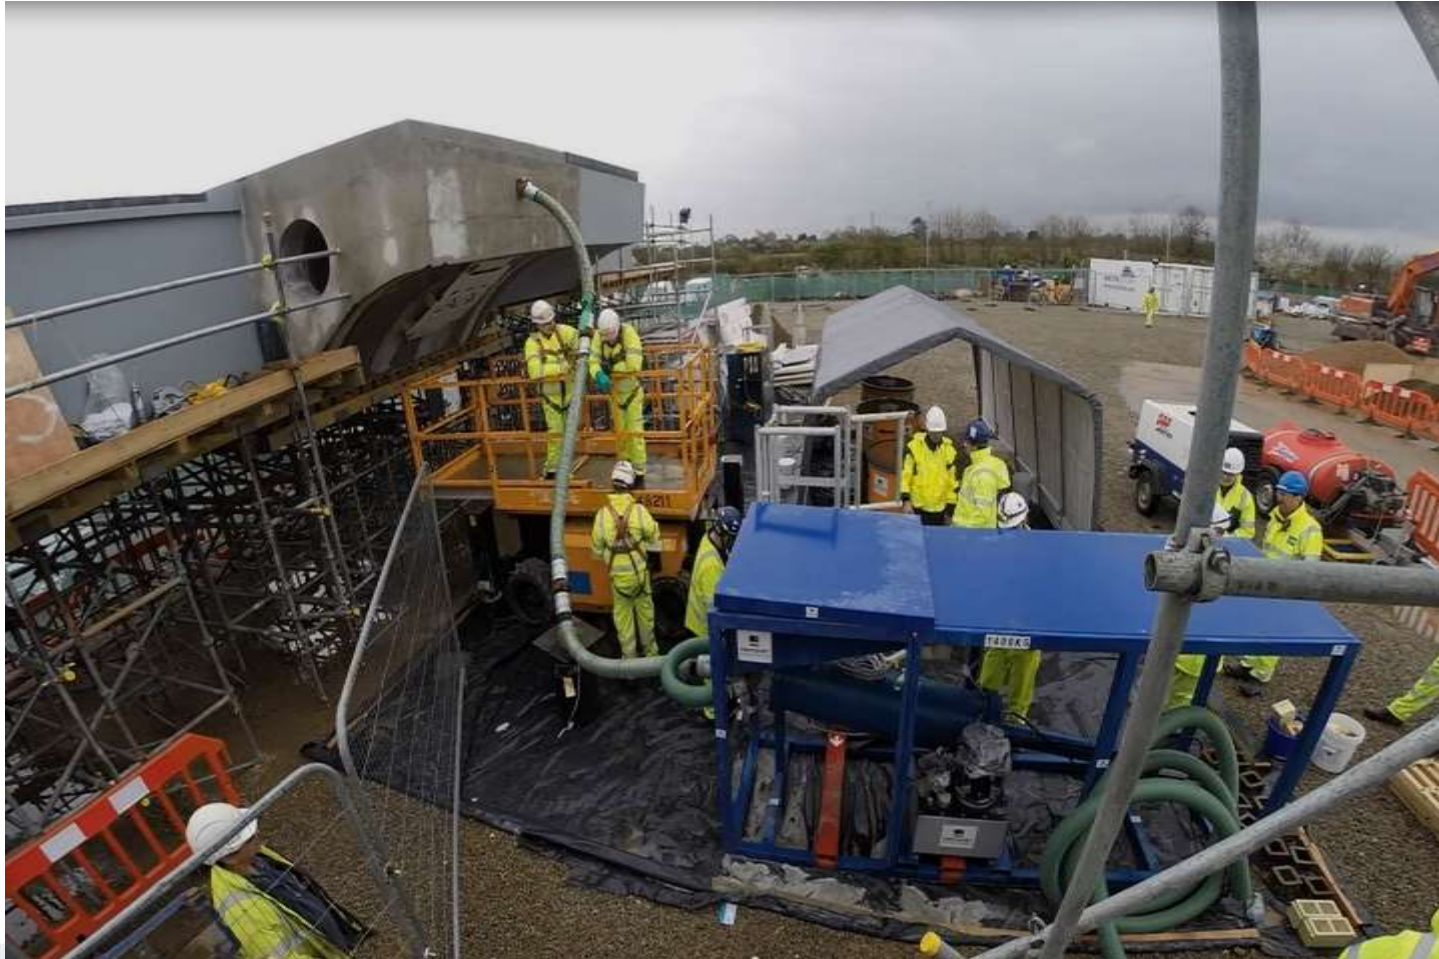
Challenge 2: Delivery of concrete for in-situ backing and space constraints

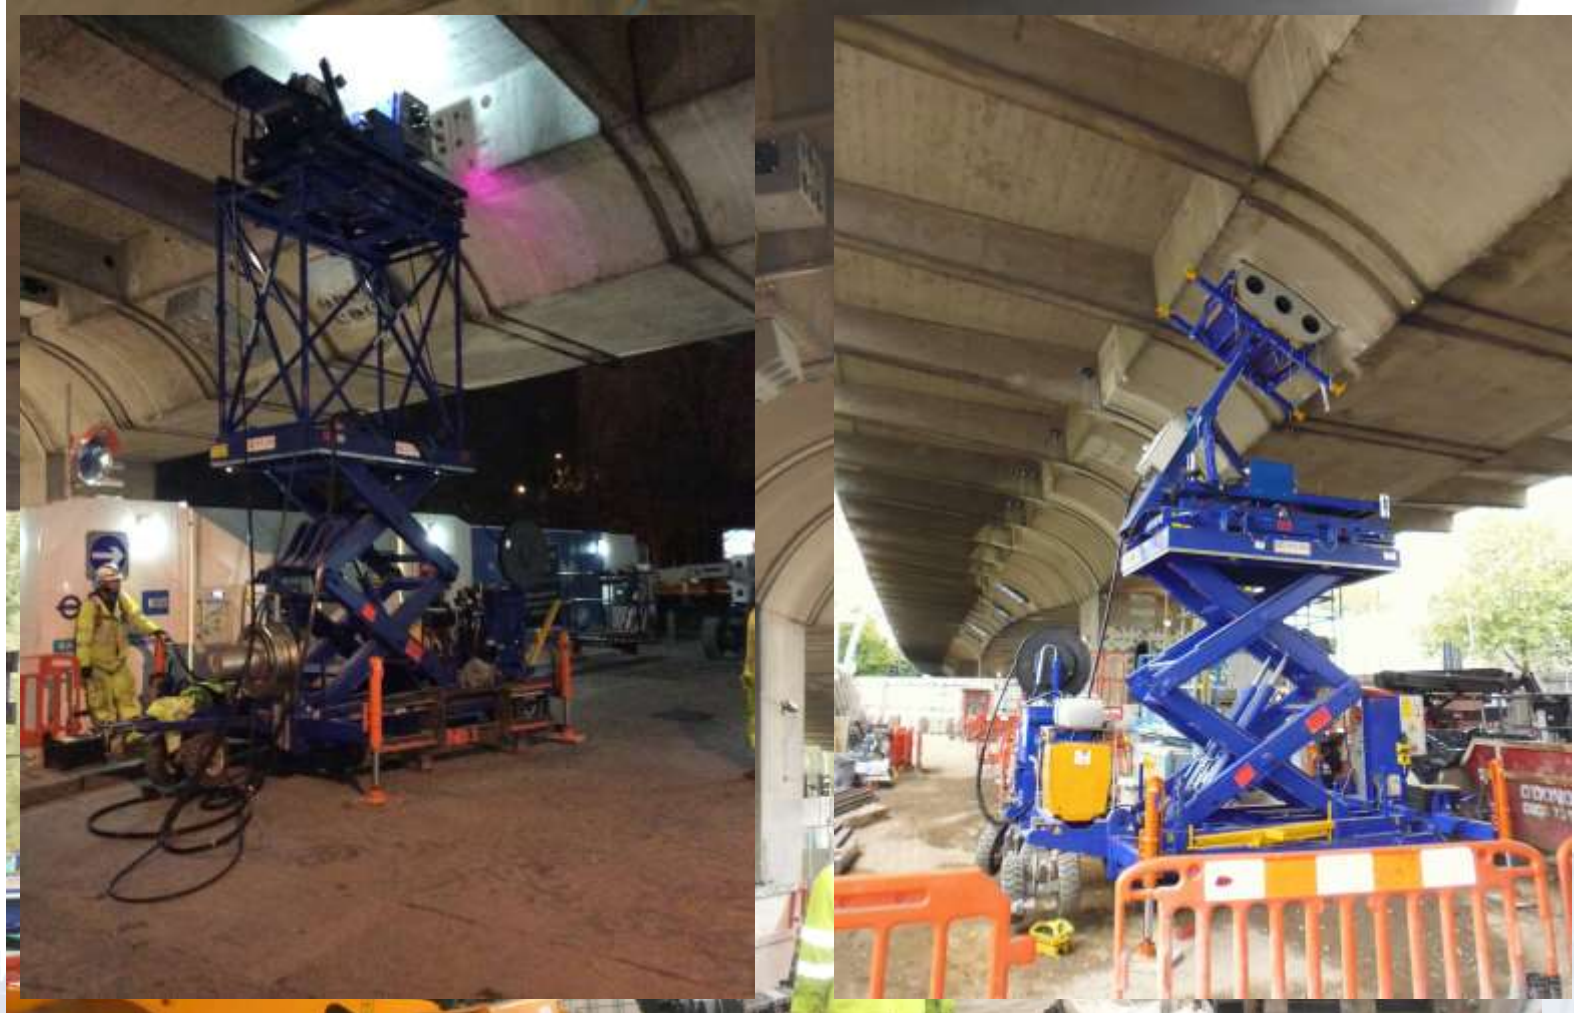
Challenge 3. Bespoke lifting equipment

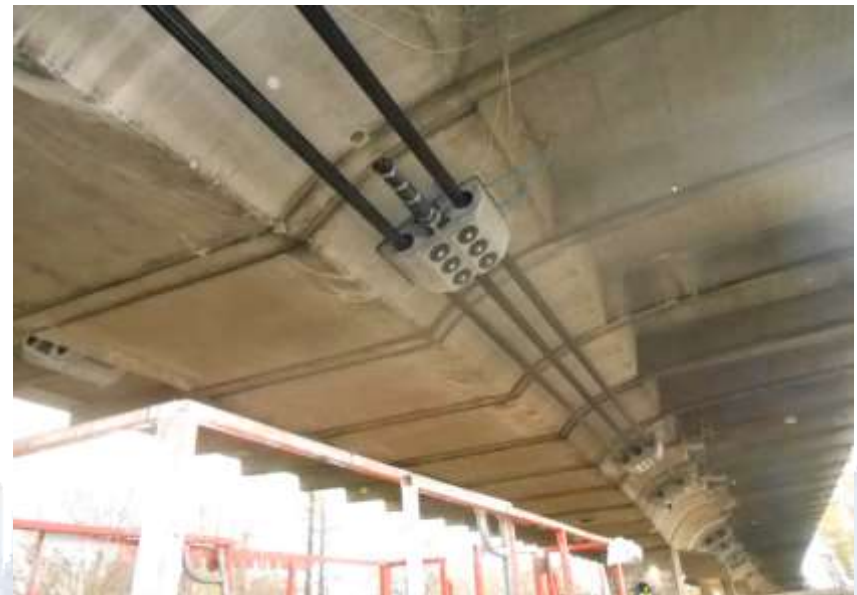
- Mid-span Tendons consist of 22 strands in each tendon.
- Galvanised and individually sheathed in a polyurethane protection coat
- Stressed to 460T, 21T in each strand

- Internal 'Long' Tendons consist of 6 number HDPE ducts, 620m long containing 37 no 16mm diameter galvanised steel strands
- Each Tendon stressed to 770T (21T per strand)
- Strands are covered in a wax, injected into the HDPE duct
- External Mid-span Tendons consist of 22 steel strands, galvanised, individually waxed and sheathed in a MDPE protection coat. Stressed to 460T, (21T per strand)
- Pier Capping Tendons 13 strands per tendons stressed to 270T
- Pier capping tendons are both internal and external

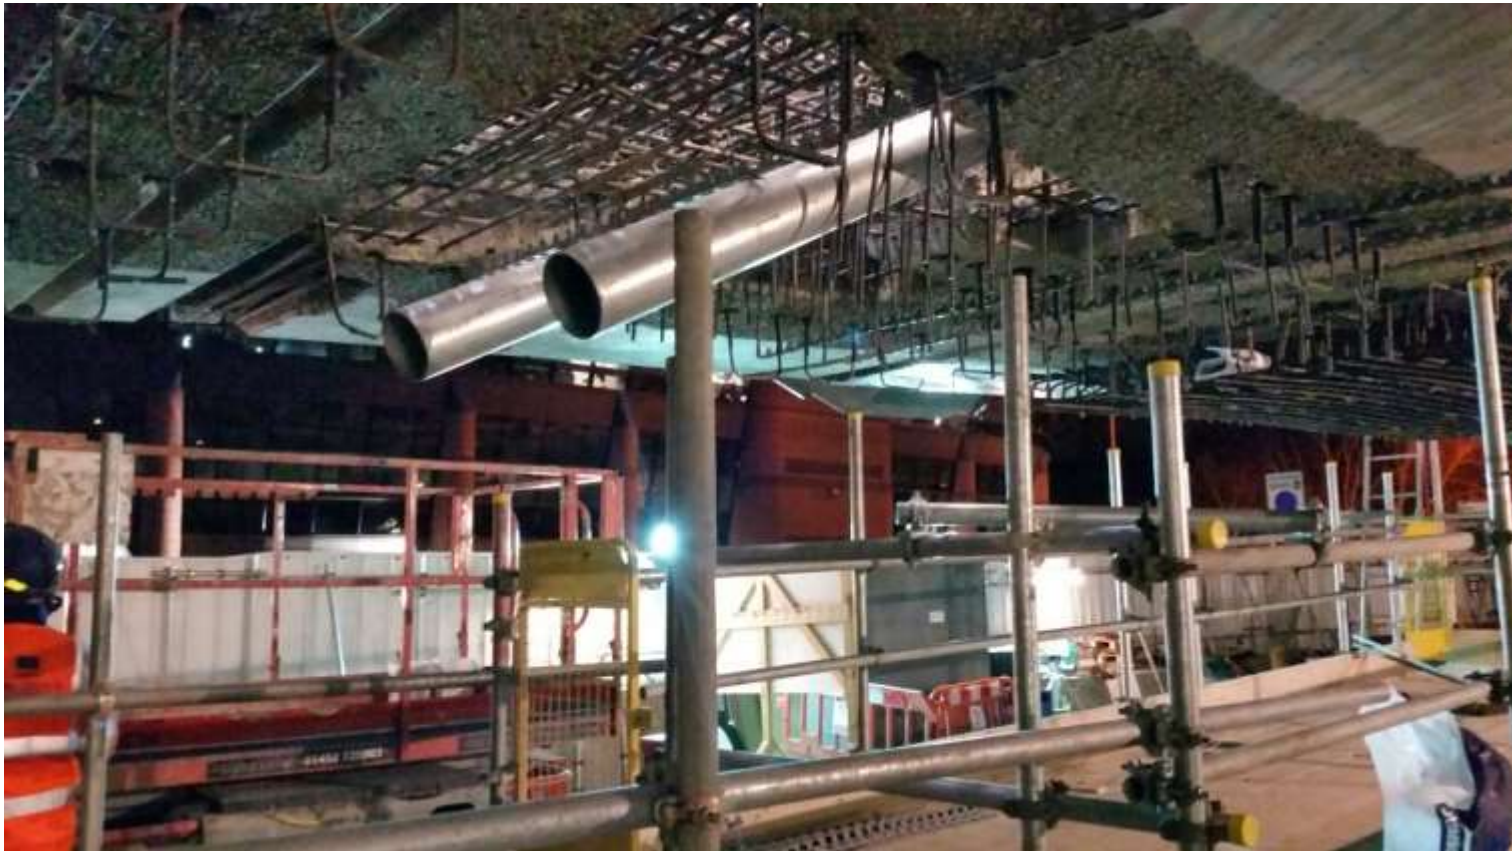
Below Deck – Post Tension Works

Long tendon anchorage works

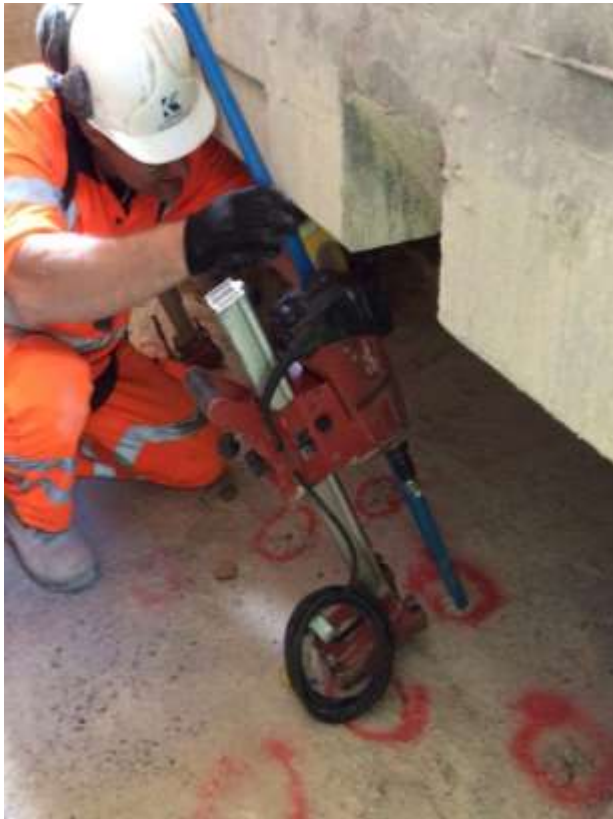
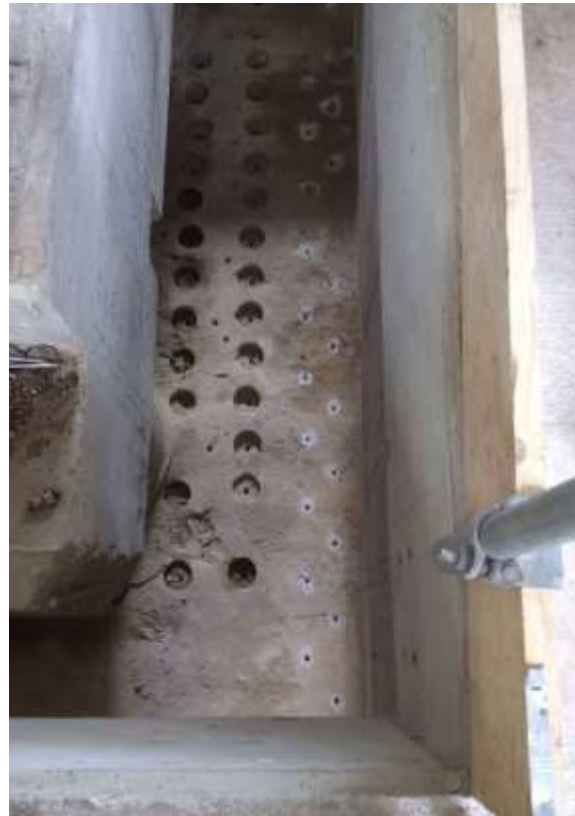
- Honeycombed pit base concrete – implementing solution

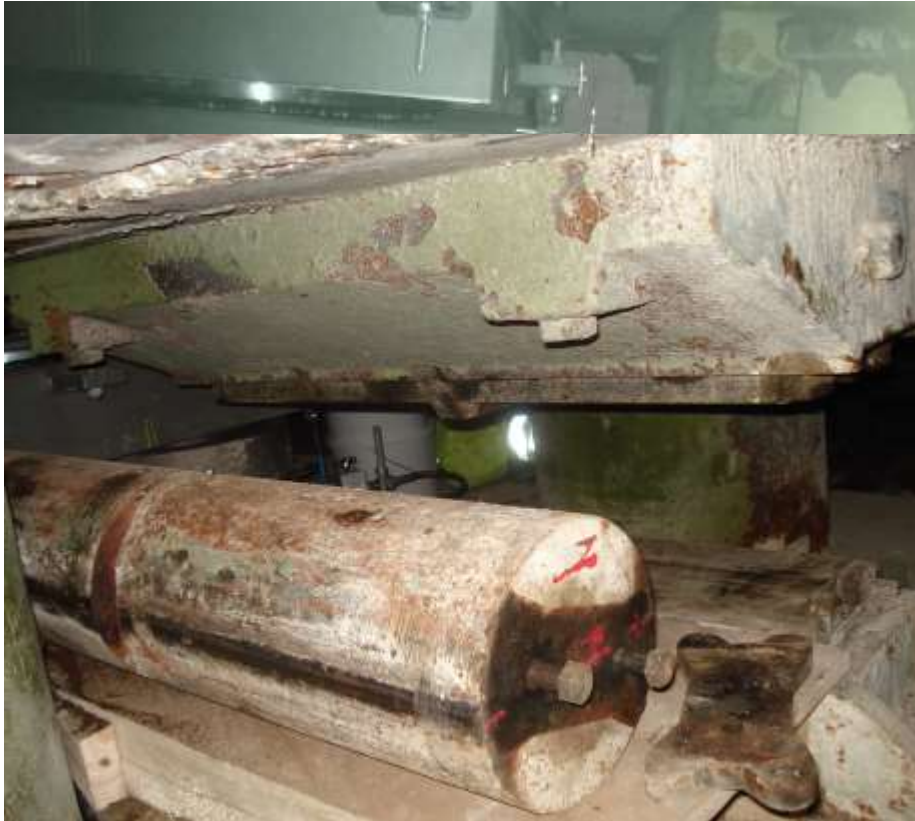
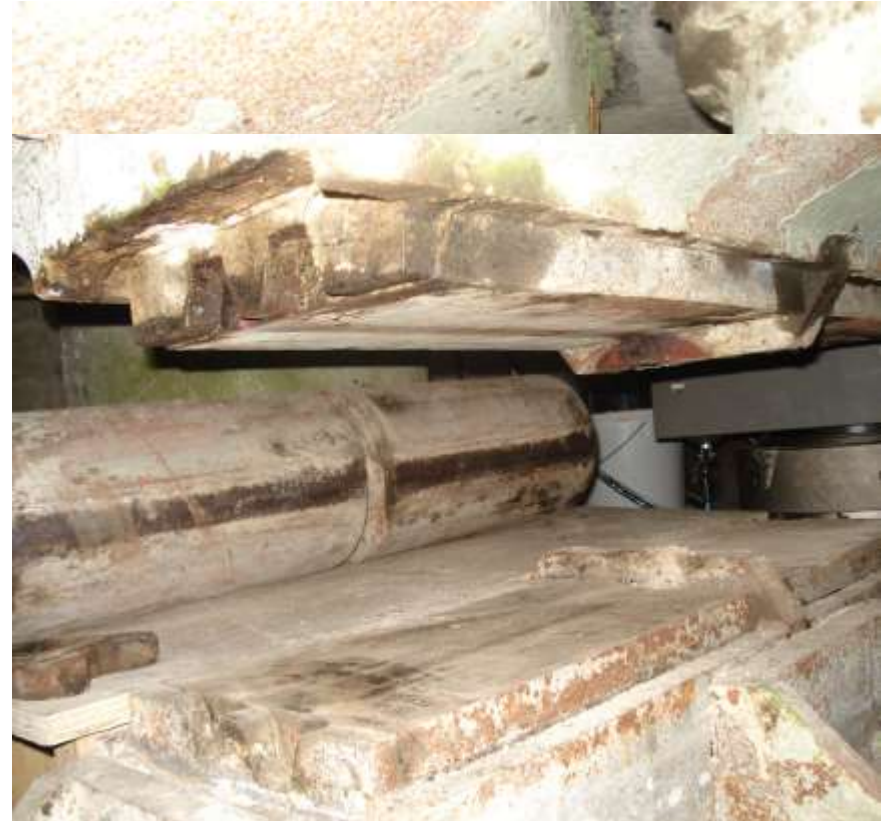
- Lifting piers solution

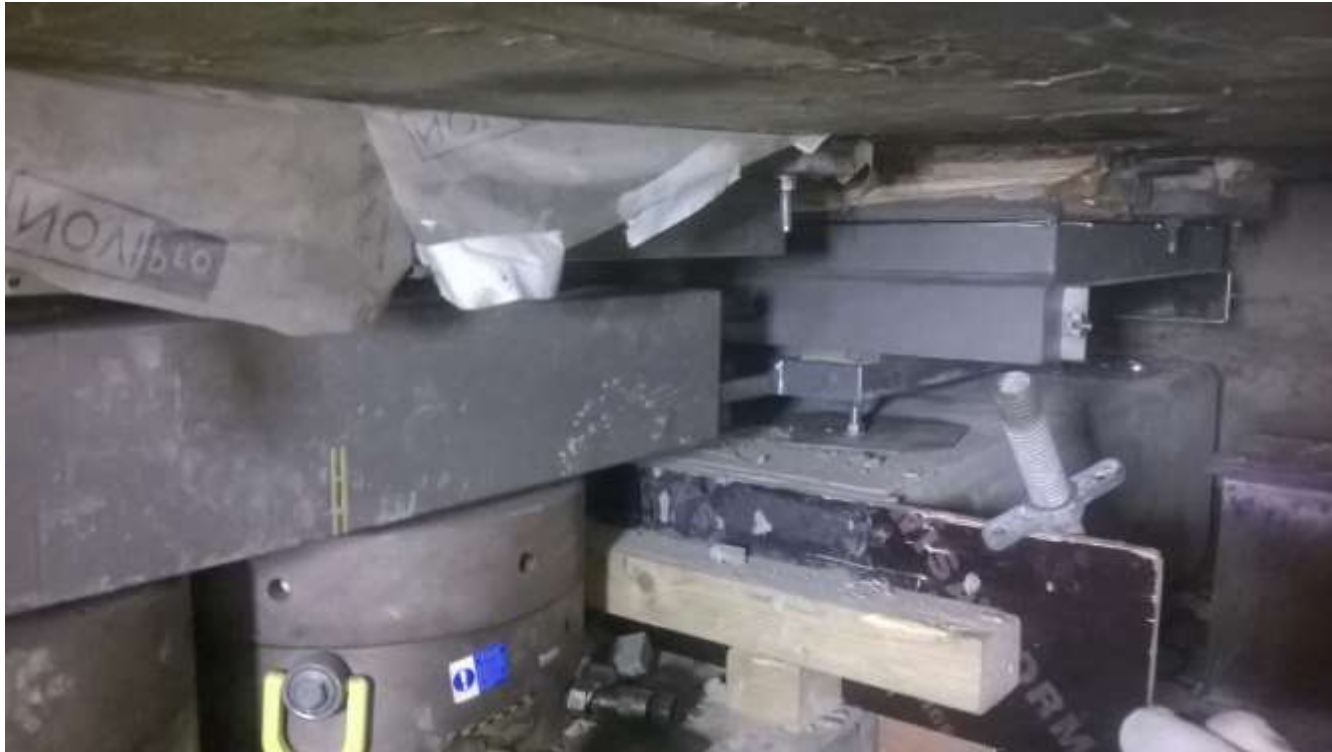
- Bearing Replacement

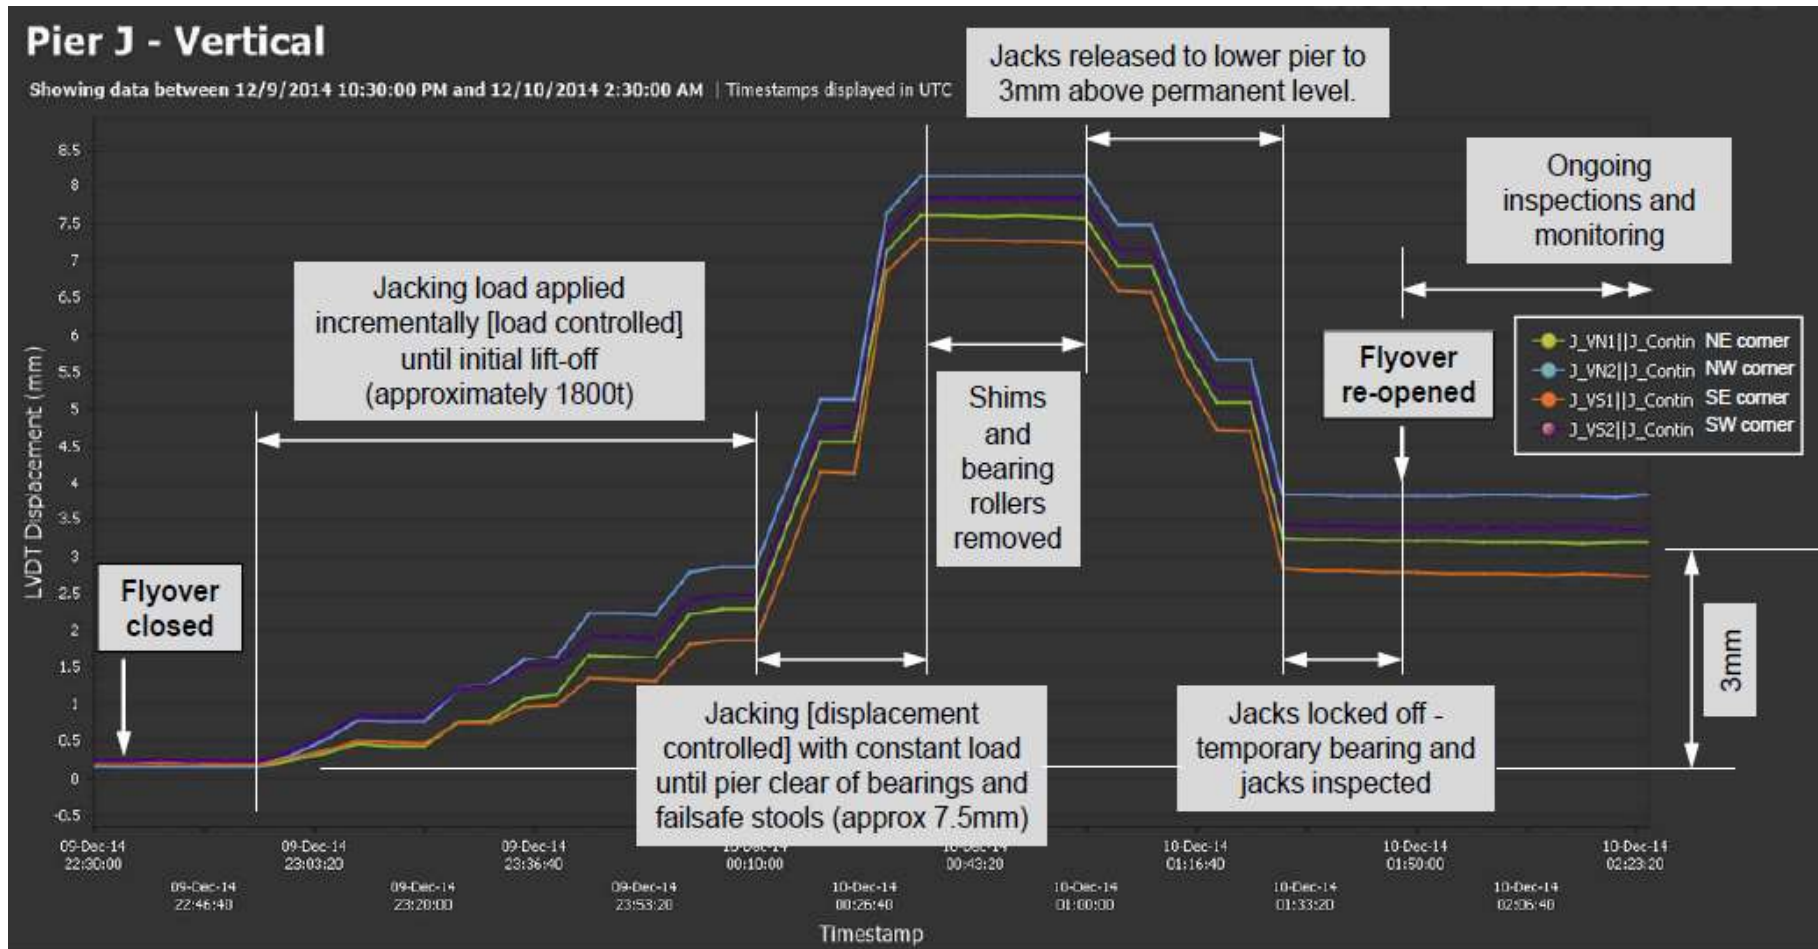
- Monitoring

09–10 Dec 2014 – HAMMERSMITH FLYOVER – Record of Jacking Pier J (levels taken on each corner of pier base)
