Hammersmith Flyover - Construction Case Study

Principal Contractor:	Costain LTD
Client:	Transport for London (TfL)
Case Study Ref. No:	CE0002
Project Number:	4000
Publication date:	March 2016
Region:	London
Sector:	Infrastructure
Contract value:	Confidential
Project timescales:	Contract Award - April 2013 Early Contractor Involvement (ECI) Phase ended -28 October 2013 Construction Phase Completion - Summer 2015
Project Themes:	Integration, collaboration and value for money

Hammersmith Flyover was constructed in the early 1960's and is situated in West London. The flyover itself lies within the boundary of the London Borough of Hammersmith and Fulham. The 622m long structure comprises sixteen spans, with a post-tensioned segmental deck and integral piers, supported on roller bearings at the base. An expansion joint located at the seventh span from the west abutment divides the flyover into two separate continuous structures.

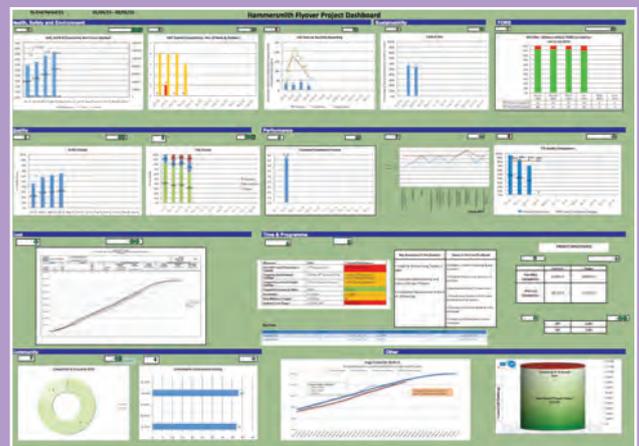
Figure 2: an extract from the project balanced scorecard logging KPI progress.

Each indicator listed was given a number of measurable objectives then allocated a RAG (RAG – 'red / amber / green) status on a monthly basis, depending on progress. Each objective has been allocated an owner who captures the data required for reporting processes. The data captured is also presented in a graphical format on a monthly reporting dashboard.

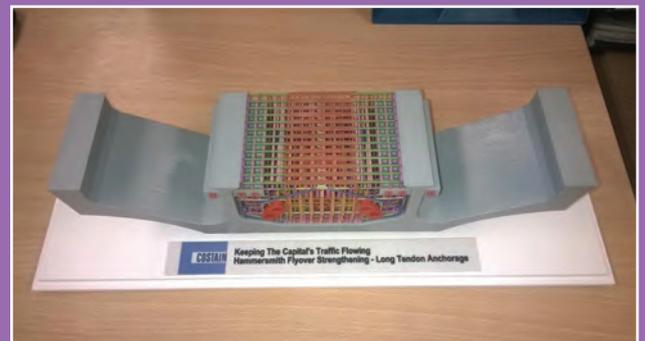
Regular workshops were held throughout the lifetime of the project to support the design development process. One such challenge was the structural strengthening works required at each end of the flyover sections to accommodate the post tensioning and abutment tie bars. The picture of the 3D printed model below demonstrates the extent to which the project team interrogated this activity. The model identified the potential reinforcement and cable duct clashes, allowing a pre-agreed solution to evolve prior to site works commencing. Reinforcement was assembled outside of the bridge as a first run study. This activity prepared site workers for the challenge of constructing the steel reinforcement cage within the confined space of the bridge deck. Once shuttering was installed the concrete was poured, from above, through diamond drill holes cut through the existing bridge deck. A C50 Tarmac top-flow self-compacting concrete mix was used to ensure concrete compaction and finish quality.

Figure 4: the 3D printed model used for clash detection

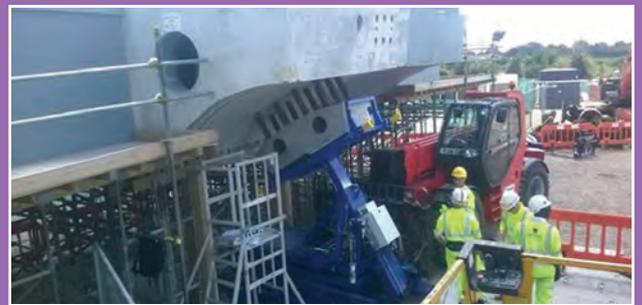
The team designed and fabricated a bespoke lifting tool capable of positioning the concrete anchorage (blister) units (weighing over two tonnes) six metres above carriageways and footways with millimetre accuracy. Efficient installation and the reduced footprint improved safety and resulted in fewer road closures, reducing the impact on local residents and businesses.

Figure 7: blister installation

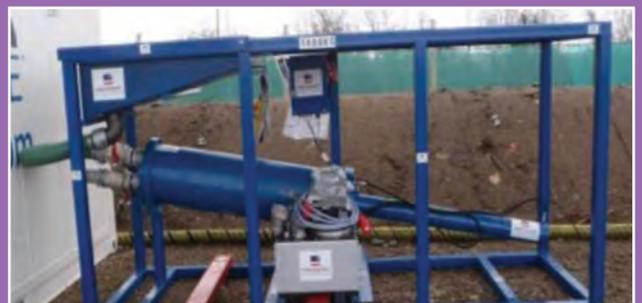
A conventional concrete pump was not appropriate for in-situ concrete installation, owing to the thixotropic nature of the specialist fibre reinforced concrete. The team developed a bespoke "syringe" concrete injection system. This solution allowed small quantities of the expensive concrete to be poured slowly and accurately, with minimum waste.

Figure 8: the concrete injection system

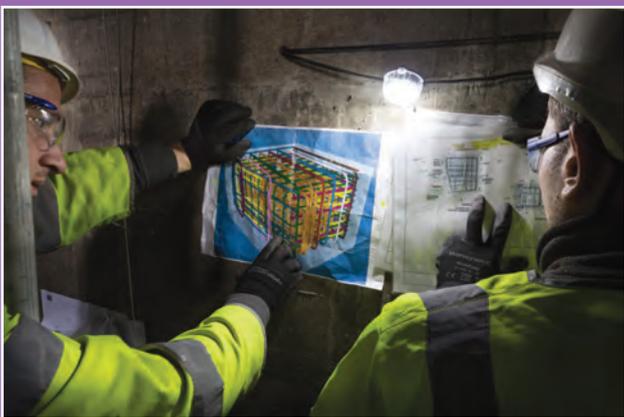
Figure 9:
3D modelling assisting with reinforcement fixing

Desktop studies of as-constructed steel reinforcement drawings and ferro scanning at blister locations was undertaken to allow core drilling to progress. However core-drilling activity was regularly halted having identified unexpected reinforcement steel within the existing concrete structure. Each instance was checked using the 3D model before approval to recommence drilling was given by the design team.
